The DZ Company, LLC
4321 W. Eisenhower Blvd.
Loveland, CO 80537
970-667-2254

Sienna Construction Note 1/3/2010

Transmitter power loss

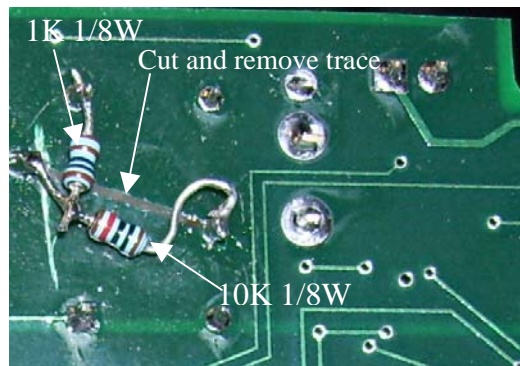
Problem: In CW and FM modes, the transmitter gradually loses power.

Cause: A hardware problem on the Tx board causes the relay that switches between CW/FM and AM/SSB not to switch, causing the local oscillator not to feed into the CW/FM waveshaping circuit except via stray capacitance.

- Cut the trace going from relay K12 pin 10 to the gate of Q21. This trace is on the back of the board. Remove the TxBPF board first to provide access to this area of the board. After cutting the trace, peel the entire trace off the board. See picture below.
- On the back of the board, solder a 10K 1/8W resistor in place of the trace you just cut. See picture below.
- Also on the back of the board, solder a 1K 1/8W resistor between the gate of Q21 and pin 1 (ground) of relay K12. See picture below.
